LOW ENERGY IMPACT LOADING
OF GRAPHITE-EPOXY PLATES

THESIS

December 1976

An experimental and theoretical analysis was performed on low energy impact loading of thin (.040 inches) graphite-epoxy plates. Six-inch square plates were subjected to dynamic impact (below the ballistic range) and static loading. The plate static strain energy and dynamic impact energy for failure were equal and constant. Theoretical analysis was performed using both exact and finite element methods. Small deflection theory was assumed and found to be inapplicable; the plates behaved in a manner indicating that a large deflection theoretical model would be more appropriate.

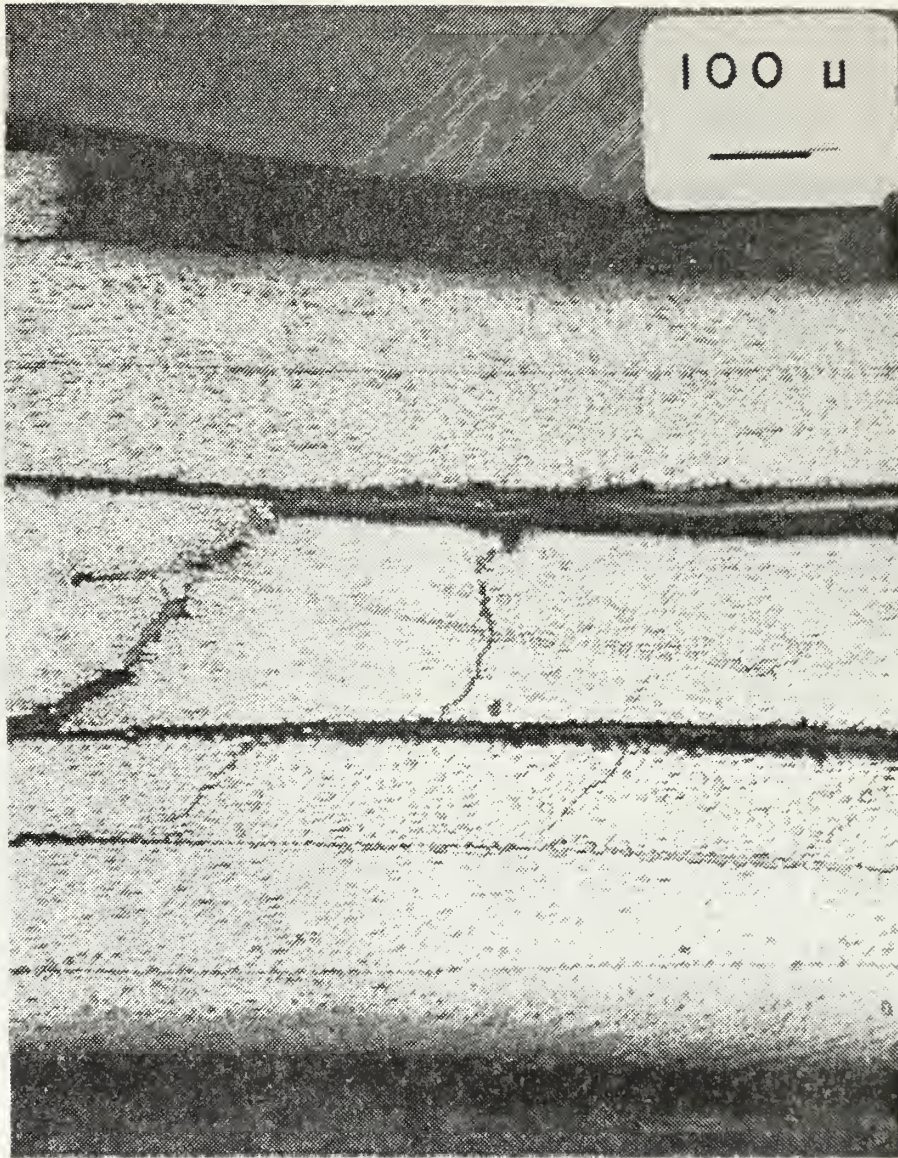
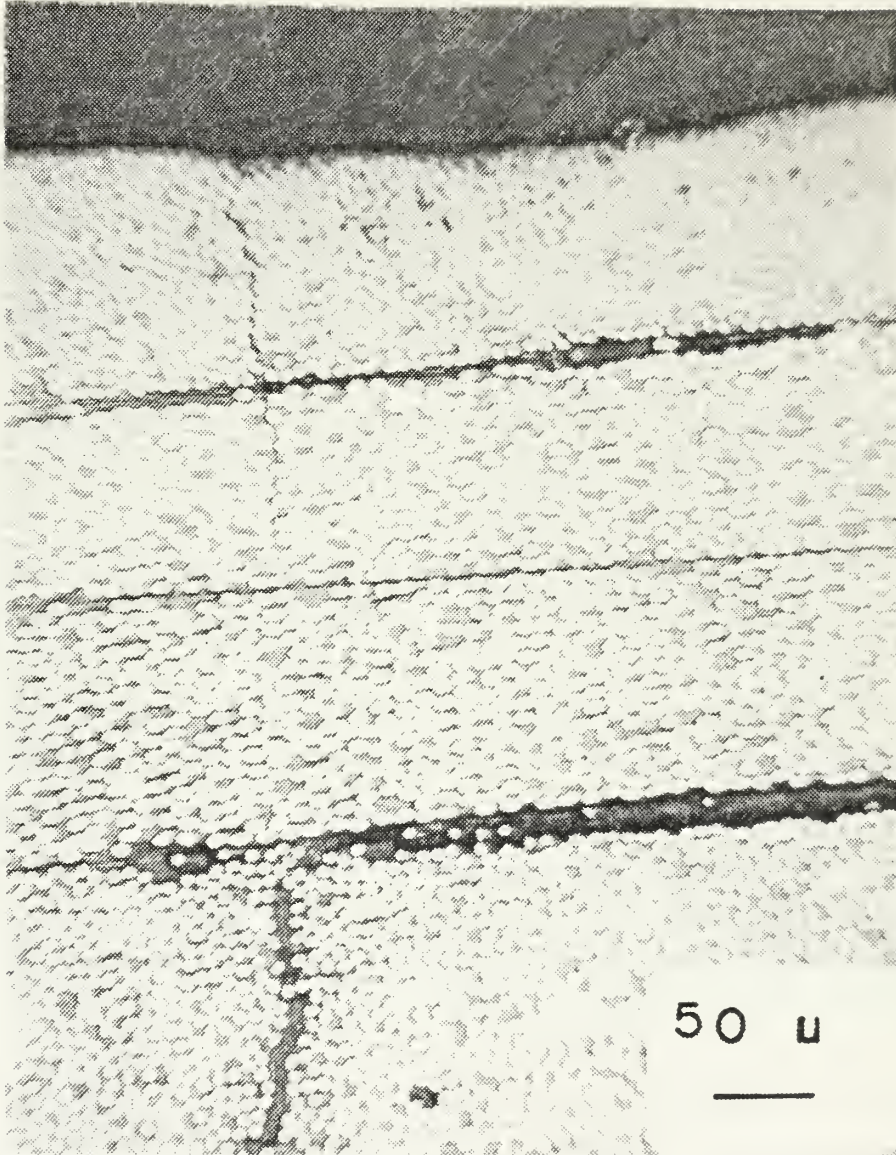
Figures 22, 23, and 24 show the lamina in the gross delamination region. These show extensive delamination, and numerous large cracks in the matrix, between fibers, penetrating entire laminas. Each delamination between laminas appears to have at least one crack penetrating the lamina directly above or below. Figure 24 illustrates this, with delaminations and associated fractures of the adjacent laminas.

Totally flexural failure damage should have been concentrated in the outermost layers where the largest stresses occurred. Figures 22, 23, and 24 all demonstrate a significant failure of the middle two layers in their

transverse direction. The assumption that the middle surface of the plate did not experience extension, therefore, is invalid. This would indicate that theoretical analysis based on small deflection theory is inappropriate.
